**FIRE SAFETY FOLLOW UP INSPECTION**

Factory Name	United Fashion Trouser Ltd.		Accord ID	10828
Address	Chaydana, P.O. National University, Gazipur			
Inspection Date	21/06/2014		Report Received Date	
Date of 1st Follow-up	12/11/2015	Date of 2nd Follow-up	22/12/2015	
Date of 3rd Follow-up	24/03/2016	Date of 4th Follow-up	25/08/2016	
Date of 5th Follow-up	24/11/2016	Date of 6th Follow-up	24/01/2017	
Date of 7th Follow-up	27/04/2017	Date of 8th Follow-up	02/08/2017	
Date of 9th Follow-up	28/12/2017	Date of 10th Follow-up	09/07/2018	
Date of 11th Follow-up	10/11/2018	Date of 12th Follow-up		
Date of 13th Follow-up		Date of 14th Follow-up		
Inspected by	Md. Jobaid Ul Islam

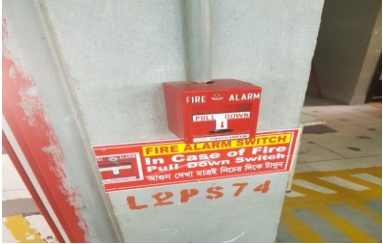
23	The fire alarm system is not installed.	Install a new listed addressable fire alarm system in accordance with NFPA 72.	Design within 4 months, install within 9 months	<p>On 24.11.2016: In progress. Design has been reviewed from Accord and installation is completed. Only testing and commissioning is balanced.</p> <p>On 24/01/2017: Installation was almost completed. Commissioning of the system in-front of contractor/ 3rd party will be done by Accord.</p> <p>On 27/04/2017: Renovation or retrofitting work is going on at this building thus the panel of this building has been found inactive during follow up inspection. Moreover factory will ensure that all products of fire alarm system will be third party certified.</p> <p>On 02/08/2017: Work in progress. Factory shall provide proper 3rd party certification for the equipment used in the system.</p> <p>On 28/12/2017: Installation will be completed soon.</p> <p>On 09/07/2018: In progress. Accord has observed T&amp;Cx. Installation is not as per NFPA-72.</p> <p>On 10/11/2018: Modification work is almost completed.</p>	'30/05/2016	Already testing commissioning completed by 9th July 2018	In Progress
