ELECTRICAL SAFETY FOLLOW UP INSPECTION REPORT (10TH)

Factory Name	Aliza fashion Ltd				Note:	
Address	Chaydana, P.O. National University, Gazipur					
FACTORY ID	12187	ELECTRICAL SAFETY INSPECTION DATES				
Initial Inspection Date	04-Apr-2015	Date of 5 th Follow Up	27-Apr-2017	Date of 11 th Follow Up	Other Factory: ----- ----- ----- ----- ----- ----- -----	
Report Received Date		Date of 6 th Follow Up	03-Aug-2017	Date of 12 th Follow Up		
Date of 1 st Follow Up	08-Sep-2015	Date of 7 th Follow Up	28-Dec-2017	Date of 13 th Follow Up		
Date of 2 nd Follow Up	08-Dec-2015	Date of 8 th Follow Up	15-May-2018	Date of 14 th Follow Up		
Date of 3 rd Follow Up	29-May-2016	Date of 9 th Follow Up	18-Jul-2018	Date of 15 th Follow Up		
Date of 4 th Follow Up	24-Nov-2016	Date of 10 th Follow Up	24-June-2019	Date of 16 th Follow Up		
Inspected by		Md Khitabul Islam

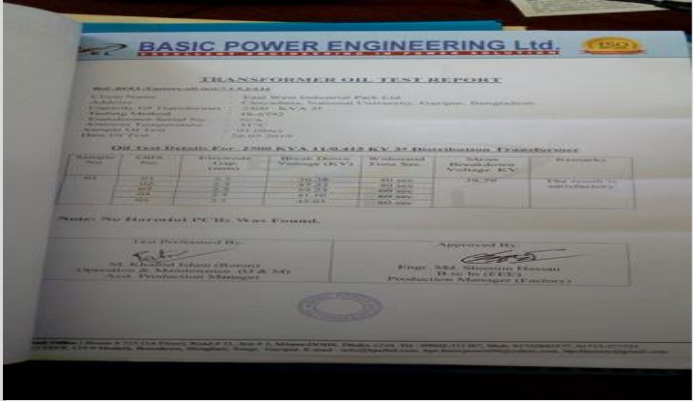
Item No	Accord Inspection Observation	Accord Action Plan (Recommendation)	Accord Time line (given in report)	Comments from Accord (After Physical Inspection)	Final Timeline (Approved timeline)	Final Action Plan (Factory)	Progress Status (On the date of inspection)	Pictorial Evidence
57	New Finding: Transformer Oil Test (dielectric strength test) report result is not satisfactory.	Transformer oil test (dielectric strength test for oil) shall be done once in a year from any govt organization.	1 Month		06-Aug-2019

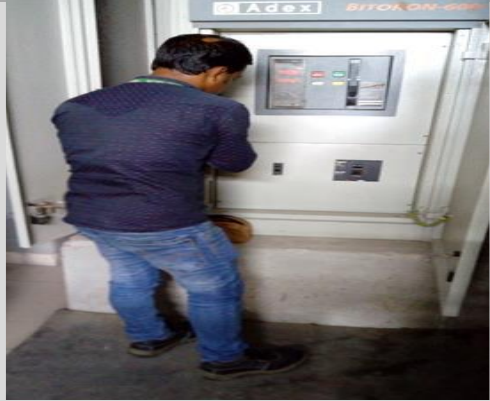
58	New Finding: Safety program is initiated but has no influence in the factory.	Electrical safety training and awareness program for the electrical personal and workers must be conducted and recorded. Training must have an impact on the safety attitude of the personnel.	1 Month		06-Aug-2019
