FIRE SAFETY FOLLOW UP INSPECTION

Factory Name	East West Fashion Garments Ltd.		Accord ID	10375
Address	Chhoydana, K.B.Bazar, National University			
Inspection Date	11/04/2015		Report Received Date	
Date of 1st Follow-up	15/09/2015	Date of 2nd Follow-up	25/02/2016	
Date of 3rd Follow-up	29/05/2016	Date of 4th Follow-up	25/08/2016	
Date of 5th Follow-up	24/11/2016	Date of 6th Follow-up	27/04/2017	
Date of 7th Follow-up	02/08/2017	Date of 8th Follow-up	28/12/2017	
Date of 9th Follow-up	09/07/2018	Date of 10th Follow-up	10/11/2018	
Date of 11th Follow-up		Date of 12th Follow-up		
Date of 13th Follow-up		Date of 14th Follow-up		
Inspected by	Md. Jobaid Ul Islam

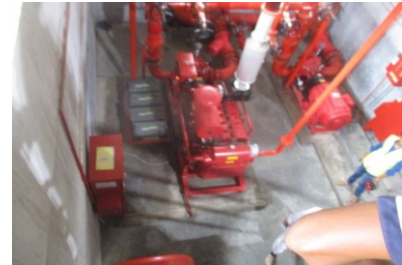
28	The required standpipe system is not installed in accordance with the ACCORD standard.	Install a new standpipe system in accordance with ACCORD standard 5.4 and NFPA 14. A class III system shall be highest occupiable floor 10 installed in buildings with the (33 ft.) above grade or more. A class I system shall be permitted in buildings protected throughout by an approved automatic sprinkler system.	within 6 months	On 24.11.2016: In progress. Design has been reviewed from Accord and installation is going on. On 24/01/2017: Installation is going on. On 27/04/2017: Installation is going on. On 02/08/2017: Work in progress. Factory shall provide proper 3rd party certification for the equipment used in the system. On 28/12/2017: Installation is completed, testing will be done by Accord. Listed equipment is required. On 09/07/2018: In progress. T&Cx has been observed by Accord. On 10/11/2018: Modification work is almost completed.	'30/03/2016		In Progress
