FIRE SAFETY FOLLOW UP INSPECTION

Factory Name	Fashion Trouser		Accord ID	11650
Address	Chaydana, National University, Gazipur, Bangladesh.			
Inspection Date	21/06/2014		Report Received Date	
Date of 1st Follow-up	06/08/2015	Date of 2nd Follow-up	08/02/2016	
Date of 3rd Follow-up	06/04/2016	Date of 4th Follow-up	11/08/2016	
Date of 5th Follow-up	18/10/2016	Date of 6th Follow-up	24/11/2016	
Date of 7th Follow-up	27/04/2017	Date of 8th Follow-up	02/08/2017	
Date of 9th Follow-up	28/12/2017	Date of 10th Follow-up	21/01/2019	
Date of 11th Follow-up		Date of 12th Follow-up		
Date of 13th Follow-up		Date of 14th Follow-up		
Inspected by	Mohammad Anayet Hossain & Nasif Javed Tofa

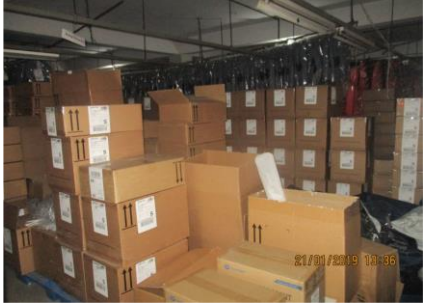
Item No	Accord Observation	Accord Recommendation	Timeline given by Accord	Comments after Physical Inspection	Supposed to complete(DD/MM/YYYY)	Final Action Plan (Factory)	Status on the date of Inspection	Pictorial Evidence
1	Areas used for combustible storage at the 3rd floor are not separated by fire-rated construction.	Provide dedicated storage rooms separated by minimum 1-hr fire-rated construction. Where separate storage rooms are not feasible, provide defined storage areas and limit the storage arrangement as follows:- Maximum height of 2.4m and maximum area of 23m ² - If sprinkler protected: maximum height of 3.66m and maximum area of 93m ² Separate areas of unenclosed combustible storage by a minimum clear distance of 3m.	Within 3 months	On 18/10/2016: In progress. Factory still has storage areas inside production floor that does not comply with Accord standard. On 24/11/2016: No action has been taken yet for 2nd floor finishing and C.T.PAT area. 27/04/2017: No action has been taken yet for 2nd floor finishing and C.T.PAT area. On 02/08/2017: Remediation work in progress. On 28/12/2017: Corrected. Storage area was not found. On 21/01/2019: Corrected as per previous follow-up.	'06/05/2016	All combustible storage has been removed with birdcall .	Corrected

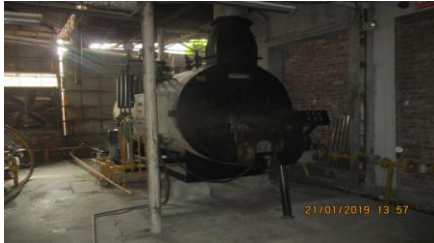
2	The boiler room located at the ground floor is not separated by fire-rated construction (openings and penetrations).	Separate the boiler room by a minimum 2-hr fire-rated construction. Seal and/or protect all openings to maintain the required fire separations.	Within 3 months	On 18/10/2016: Corrected as per site observation. On 24/11/2016: Corrected as per site observation. Boiler room is placed to ground floor and separated by fire rated construction. 27/04/2017: Corrected as per site observation. Boiler room is placed to ground floor and separated by fire rated construction. On 02/08/2017: Corrected. On 28/12/2017: Corrected as on previous follow ups. On 21/01/2019: Corrected as per previous follow-up. Note: Unseal penetration observed from boiler room to exit stair.	'06/04/2016	corrected on 2nd flow up	Corrected

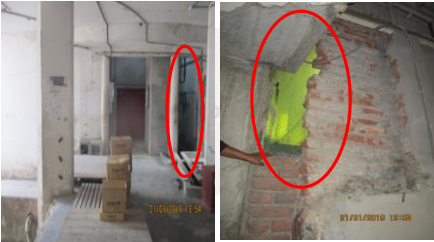
3	The exit stairs are not separated from work areas and other spaces on each floor by fire related construction. Both stairs have unprotected openings.	Provide minimum 1.5-hr fire rated doors and seal all unprotected openings to separate the exit stairs from work areas and other building spaces on all floor levels. Ensure that the fire doors are self-closing and positive latching and that they are provided with fire exit (panic) hardware where serving production floors. If fire doors are required to be held open for functional reasons, provide automatic closing devices tied to the fire alarm	Within 3 months	On 18/10/2016: It has been observed same as last follow-up. Additionally, other work areas (office, small production) except main production area are still not separated from exit stair with fire rated assemblies. Factory will provide fire door. Fire doors for this purpose are in-house. Fire door has been installed in production floor's exits. On 24/11/2016: Fire door installation is going on and interfacing with fire alarm system is not completed yet. 27/04/2017: Fire door installation is going on and interfacing with fire alarm system is not completed yet. On 02/08/2017: Remediation work in progress. Door co-ordinators were missing. Few doors were welded later without keeping integrity of fire doors. On 28/12/2017: Some doors were found damaged which was welded and painted later without keeping integrity of fire doors. Un-authorized modified doors shall be replaced. On 21/01/2019: Exit stairs are not properly separated yet on ground floor.	'06/05/2016	Interfacing with fire alarm system completed. Waiting for Testing commissioning	In Progress

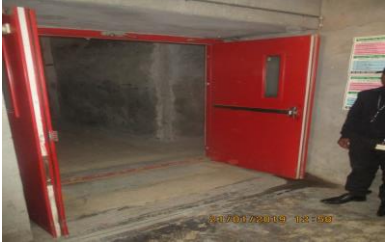
Item No	Accord Observation	Accord Recommendation	Timeline given by Accord	Comments after Physical Inspection	Supposed to complete(DD/MM/YYYY)	Final Action Plan (Factory)	Status on the date of Inspection	Pictorial Evidence
9	Collapsible and sliding gates are provided at most exit stairs.	Replace all collapsible and roll-up gates along the means of egress with side-hinged, swinging egress doors. If locks are required for security reasons, utilize special door locking features complying with NFPA 101.	Within 3 months	On 18/10/2016: Corrected as per site observation. On 24/11/2016: Corrected. 27/04/2017: Corrected. On 02/08/2017: Corrected. On 28/12/2017: Corrected as on previous follow ups. On 21/01/2019: Corrected.	'06/04/2016	Already replace all collapsible and roll-up gates along the means of egress with side-hinged, swinging egress doors as per NFPA 101.	Corrected

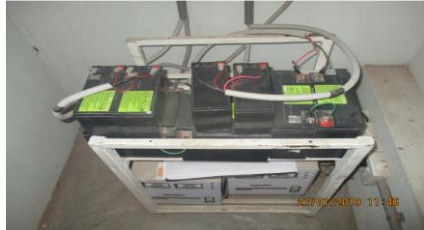
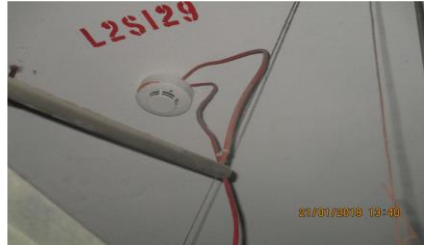
10	The fire alarm system is antiquated, not a listed system, and does not provide alarm and notification features consistent with acceptable standards	Replace the fire alarm system with a new, listed addressable fire alarm system in accordance with NFPA 72.	Design within 4 months, install within 9 months	On 24/11/2016: Partially corrected. Reviewed drawing from Accord was available during 6th follow-up inspection. Installation was almost completed. Fire doors, HVAC system, fire pump controls should be interfaced with FACP if applicable. Factory have to prove whether the installed fire alarm cable has been certified by any third party or not. (Commissioning of the system in-front of contractor/ 3rd party will be done by Accord) 27/04/2017: Found same as before. On 02/08/2017: Observed same as before. Factory shall provide 3rd party certification for all the equipment used in the system. On 28/12/2017: Factory conforms that installation is completed. Testing will be done by accord. On 21/01/2019: T&C was conducted. Deficiencies were stated below. As built design fully mismatch with the actual site plan. Schematic diagram, voltage drop, battery calculation shall be updated. Improper spacing was observed for detectors. No mark or 3rd party label was observed for cable. Fabricated label was found on the body of smoke detectors. Provided certificate mismatched for MCP. Panel couldn't detect Open loop fault. Temporal -3 sound pattern shall be provided for sounders. Detectors, MCP & sounders missing where required. Per NAC current exceeds its provided current capacity. Battery was not protected. Wiring is not protected from physical damage. Interfacing was found improper (exhaust fan). Installation work shall be as per NFPA 72.	'30/05/2016	Installation has been completed .Waiting for Testing commissioning	In Progress

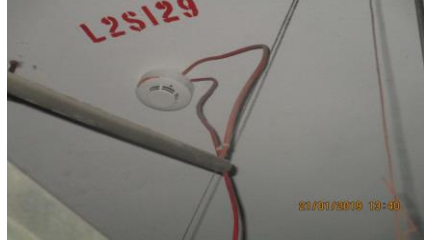
12	The building is equipped with single-station smoke alarms. Smoke alarm activation sounds only a local alarm and does not provide automatic fire alarm	Replace the single-station smoke alarms with automatic smoke detectors tied into the fire alarm system in accordance with NFPA 72.	Within 6 months	On 18/10/2016: Integrated part of fire alarm system. On 24/11/2016: Integrated part of fire alarm system. 27/04/2017: Integrated part of fire alarm system. On 02/08/2017: Integrated part of FA. On 28/12/2017: Integrated part of fire alarm system. On 21/01/2019: Integrated part of fire alarm system.	'30/05/2016	Installation has been completed .Waiting for Testing commissioning	In Progress

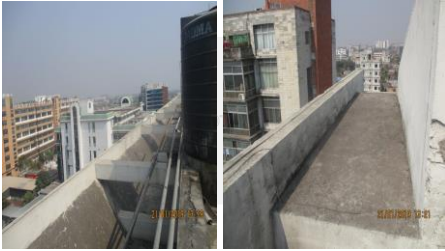
14	New Finding (1st Follow-up): 42 inch parapets or guards are not provide in occupiable roof.	Provide parapets or guards with a minimum height of 1067mm (42 inch.).	Within 3 months	On 18/10/2016: Corrected as per site observation. On 24/11/2016: Corrected. 27/04/2017: Corrected. On 02/08/2017: Corrected. On 28/12/2017: Corrected as on previous follow ups. On 21/01/2019: In progress.	'06/04/2016	Corrected	In Progress

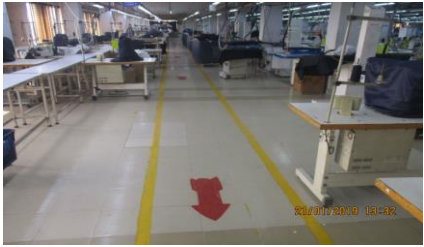
15	New Finding (1st Follow-up): Width of aisles is less than 0.9m (36-in.). Location: 3rd floor.	Aisles shall be provided with a minimum unobstructed clear-width of 0.9 m (36 in.).	22-Aug-15	On 11/08/2016: Corrected. On 24/11/2016: Corrected. 27/04/2017: Corrected. On 02/08/2017: On 28/12/2017: Corrected as on previous follow ups. On 21/01/2019: Corrected.	'06/04/2016	Aisles already provided with a minimum unobstructed clear-width of 0.9 m (36 in.).	Corrected

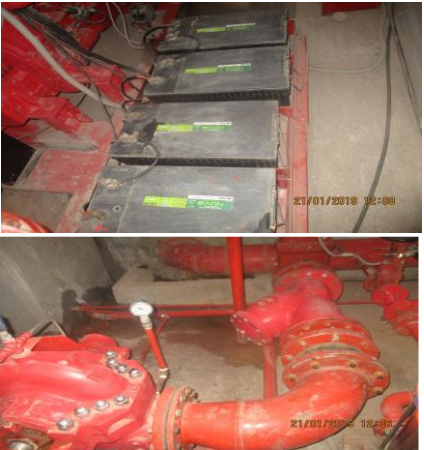
16	New Finding (1st Follow-up): The existing factory building with an occupiable floor greater than 10 m (33 ft) above the finished grade is not protected with an approved standpipe system.	Provide a standpipe system throughout the building in accordance with NFPA 14.	Within 6 months	On 18/10/2016: Equipment's are in-house. Installation in-progress. On 24/11/2016: Equipment's are in-house. Installation in-progress. 27/04/2017: Installation is going on. On 02/08/2017: Remediation work in progress. Installation work is ongoing. Factory shall provide proper 3rd party certification for equipment used in the system. On 28/12/2017: Factory conforms that installation is completed, all equipment shall be listed. Testing will be done by accord. On 21/01/2019: T&C was conducted. Deficiencies were stated below. Vortex plate was missing. As built design fully mismatched with the actual site. Reservoir was found manual refill condition. 10D rule shall be followed in the suction section. PRV pressure shall be as per NFPA 20. Fuel tank capacity was not found. Phase loss trouble shall be provided for EE pump. Battery was found unprotected. Improper drainage system. Landing valve shall be provided on the roof floor also. Non listed pressure gauge observed. Improper cut in and cut out pressure for each pump. Pressure sensing line shall be as per standard.	'08/05/2016	Installation has been completed .Waiting for Testing commissioning	In Progress

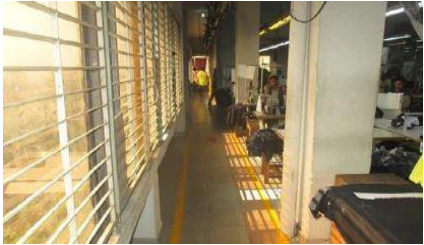
Item No	Accord Observation	Accord Recommendation	Timeline given by Accord	Comments after Physical Inspection	Supposed to complete(DD/MM/YYYY)	Final Action Plan (Factory)	Status on the date of Inspection	Pictorial Evidence
22	New Finding (5th Follow-up): During the inspection egress aisles were obstructed by combustible storages and available clear width were found less than 36 inch.	Provide aisles free from obstructions and with minimum clear widths of 36-inch.	Immediate	On 18/10/2016: New Finding. On 24/11/2016: Corrected. 27/04/2017: Corrected. On 02/08/2017: Issue reopened. Many egress aisles were observed obstructed with combustible storages. On 28/12/2017: Corrected. On 21/01/2019: Corrected.	'31/10/2016	Provided aisles free from obstructions and with minimum clear widths of 36-inch.	Corrected

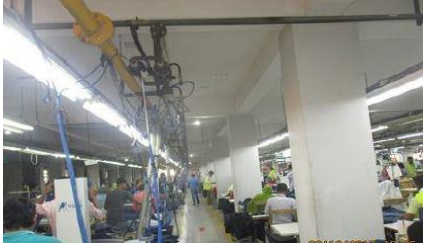
23	New Finding (5th Follow-up): Steam line pipes were non-insulated and were on the floor level, obstructing that egress path.	Provide heat insulation to the pipes Or Modify the pipe lines arrangement that does not obstruct the egress path	Within 1 month	On 18/10/2016: New Finding. On 24/11/2016: No action has been taken yet. 27/04/2017: This is not a steam line. This is an obstacle in egress path which shall be removed. On 02/08/2017: Corrected. Steam line has been modified to ceiling mount. On 28/12/2017: Corrected as on previous follow ups. On 21/01/2019: Corrected as on previous follow ups.	'18/11/2016	Provided heat insulation to the pipes.	Corrected

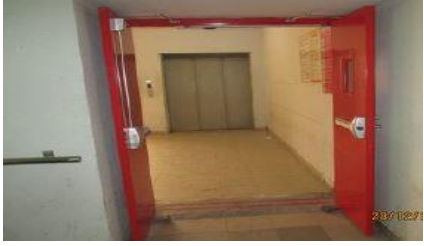
24	New Finding (On 02.08.2017): Unsealed elevator shafts are located inside the working place at all floors.	Provide a minimum 2-hr fire-rated elevator shaft to separate from each floor level and seal all penetrations in floor/ceiling assemblies to maintain the fire separation.	Within 1 month	On 02/08/2017: New Finding On 28/12/2017: Corrected. Fire door installed, lift area shall be always free. On 21/01/2019: Corrected.	'03/09/2017	Fire doors has been install	Corrected
