FIRE SAFETY FOLLOW UP INSPECTION

Factory Name	Rumana Fashion Ltd.	Accord ID	9607
Address	Chaydana, P.O. National University		
Initial Inspection Date	29-Apr-2014	Report Received Date	
Date of 1st Follow-up	13-Nov-2014	Date of 2nd Follow-up	08-Dec-2015
Date of 3rd Follow-up	29-May-2016	Date of 4th Follow-up	24-Nov-2016
Date of 5th Follow-up	27-Apr-2017	Date of 6th Follow-up	03-Aug-2017
Date of 7th Follow-up	28-Dec-2017	Date of 8th Follow-up	15-May-2018
Date of 9th Follow-up	24-Jun-19	Date of 10th Follow-up	
Date of 11th Follow-up		Date of 12th Follow-up	
Date of 13th Follow-up		Date of 14th Follow-up	
Inspected by	A N Faisal Ahmed

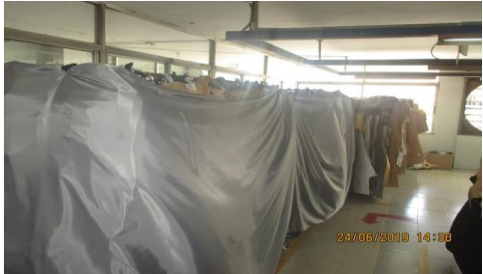
Item No	Accord Observation	Accord Recommendation	Timeline given by Accord	Comments after Physical Inspection	Supposed to complete(DD/MM/YYYY)	Final Action Plan (Factory)	Status on the date of Inspection	Pictorial Evidence
1	Area used for combustible storage are not separated by fire rated construction.All floor hand large quantites of storage on the factory floor	Provide dedicated storage rooms separated by minimum 1-hr fire-rated construction.Where separate storage rooms are not feasible, provide defined storage areas and limit the storage arrangement as follows: - Maximum height of 2.4m and maximum area of 23m ² - If sprinkler protected: maximum height of 3.66. Separate areas of unenclosed combustible storage by a minimum clear distance of 3m.	Within 3 months	On 8-12-15: In progress. On 29-5-16: Still found at several floors. On 24-11-16: Corrected. Store room & Finished goods on ground floor has been separated from production floor by fire rated construction. In process goods has been found on organized condition as per ACCORD recommendation. On 27/04/2017: Corrected. On 03/08/2017: Corrected as per previous follow-up. On 28/12/2017: Corrected On 15-5-2018: Corrected. On 24/06/2019: Corrected. Note: Factory shall maintain the area limit in all area properly	20-Dec-2015	Already Provided dedicated storage rooms separated by minimum 1-hr fire-rated construction	Corrected

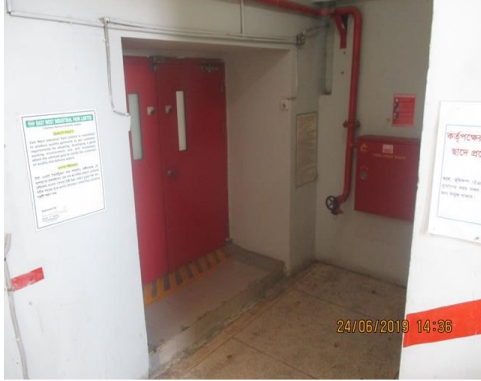
Item No	Accord Observation	Accord Recommendation	Timeline given by Accord	Comments after Physical Inspection	Supposed to complete(DD /MM/YYYY)	Final Action Plan (Factory)	Status on the date of Inspection	Pictorial Evidence
3	The Exit stairs are not separated from work or storage area on each floor by fire-rated construction	Provide minimum 1.5-hr fire rated doors and seal all unprotected openings to separate the exit stairs from work areas and other building spaces on all floor levels. Ensure that the fire doors are self closing and positive latching and that they are provided with fire exit (panic) hardware where serving production floors. If fire doors are required to be held open for functional reasons, provide automatic-closing devices tied to the fire alarm system.	Within 3 months	<p>On 27/04/2017: Compressor separation work is going on. Some doors have been found non functional due to doors leaf broken, door hold open devices and door coordinators are non functional.</p> <p>On 03/08/2017: Fire door installation work is in progress in few floors. Door coordinators, smoke seals were missing. Fire doors were found open through some external sources.</p> <p>On 28/12/2017: Partially Corrected. All the fire rated doors were not found functional during inspection, some were found physically modified.</p> <p>On 15-5-2018: Fire door functionality tested and found ok. Physically modified fire doors have been replaced. Doors were interfaced.</p> <p>On 24/06/2019: Corrected as per previous follow up.</p>	15-Dec-2015	All floor doors install properly .	Corrected

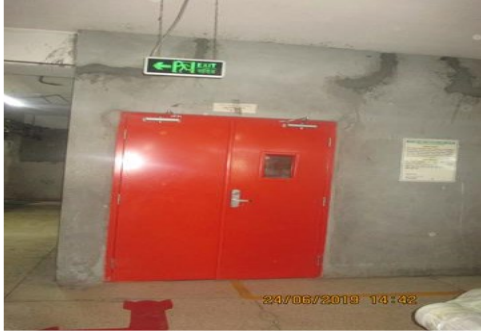
4	Storage rooms used for combustible storage are not separated by fire rated construction on all floor	Provide dedicated storage rooms separated by minimum 1-hr fire-rated construction. Where separate storage rooms are not feasible, provide defined storage areas and limit the storage arrangement as follows: - Maximum height of 2.4m and maximum area of 23m ² - If sprinkler protected: maximum height of 3.66m and maximum area of 93m ² . Separate areas of unenclosed combustible storage by a minimum clear distance of 3m.	Within 3 months	<p>On 8-12-15: Fire door installation work is in progress.</p> <p>On 29-5-16: Fire door is still to be provided at storage room.</p> <p>On 24-11-16: Fire door installation has been completed for this store room.</p> <p>On 27/04/2017: Corrected as per previous follow up. Note: Factory will ensure that the installed fire doors are functional with all necessary equipment.</p> <p>On 03/08/2017: Corrected as per previous follow up.</p> <p>On 28/12/2017: Corrected.</p> <p>On 15-5-2018: Corrected.</p> <p>On 24/06/2019: Corrected.</p>	22-Dec-2015	Already provided dedicated storage rooms separated by minimum 1-hr fire-rated construction	Corrected

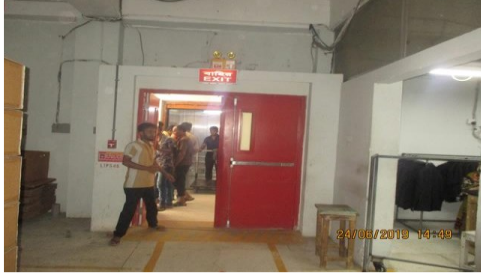
5	Egress doors and gates with locking features are provided at building exits, and at exit discharge at various locations throughout the building .All gates/doors were open and unlock during visit	Remove locking features from all egress doors and gates.If locks are required for security reasons, utilize special door locking features complying with NFPA 10	Immediately	<p>On 8-12-15: Corrected.</p> <p>On 29-5-16: Corrected.</p> <p>On 24-11-16: Corrected.</p> <p>On 27/04/2017: Corrected.</p> <p>On 03/08/2017: Corrected.</p> <p>On 28/12/2017: Corrected</p> <p>On 15-5-2018: Corrected.</p> <p>On 24/06/2019: Corrected.</p>	13-Nov-2014	Already remove locking features from all egress doors and gate .	Corrected

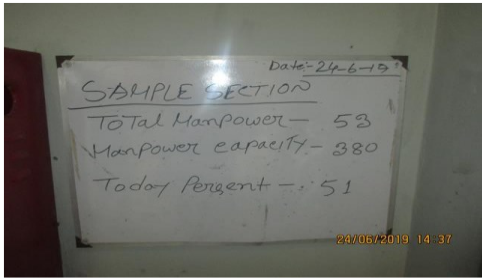
7	Exit Capacity (380) is not adequate for the occupant load (419) on floor 1	Immediately reduce occupant load to not more than available exit capacity. If possible, provide additional exits in the future to increase capacity.	Immediately	On 8-12-15: Corrected. On 29-5-16: Corrected. On 24-11-16: Corrected. On 27/04/2017: Corrected. On 03/08/2017: Corrected. On 28/12/2017: Corrected On 15-5-2018: Corrected. On 24/06/2019: Corrected.	20-Dec-2014	We have done this work by removing 40 worker to another adequate place .	Corrected

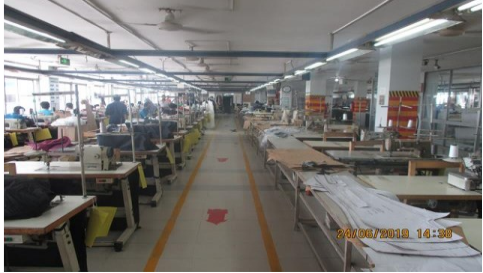
9	The width of egress aisles is less than 36 inch between tables in the sample area of the fifth floor and between the cutting tables and central columns on the	Provide minimum aisle widths of 36-in.	Within 3 months	On 8-12-15: No action has been taken yet. On 29-5-16: Still several aisles were found less than required width. Some aisles were found blocked by work materials On 24-11-16: Corrected. On 27/04/2017: Corrected. On 03/08/2017: Corrected as per previous follow-up. On 28/12/2017: Corrected On 15-5-2018: Corrected. On 24/06/2019: Corrected.	15-Dec-2015	Already Provided minimum aisle widths of 36-in.	Corrected

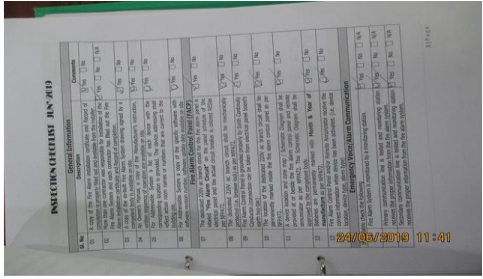
11	Inspection testing and maintenance for the fire alarm system was not in accordance with NFPA 72	Inspect, test and maintain the fire alarm system, and keep written records on-site, in accordance with NFPA 72.	Within 3 months	On 8-12-15: No action has been taken yet On 29-5-16: No record could be shown. On 24-11-16: Corrected On 27/04/2017: Corrected as per previous follow up. On 03/08/2017: Corrected On 28/12/2017: Corrected On 15-5-2018: Corrected. On 24/06/2019: Corrected.	30-Mar-2016	Already inspect, test and maintain the fire alarm system, and keep written records on-site, in accordance with NFPA 72	Corrected

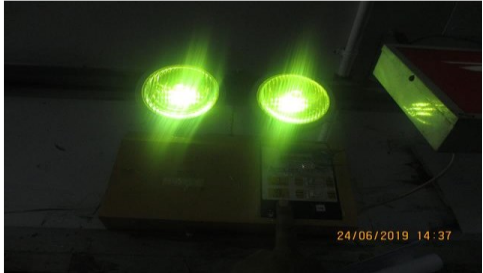
Item No	Accord Observation	Accord Recommendation	Timeline given by Accord	Comments after Physical Inspection	Supposed to complete(DD /MM/YYYY)	Final Action Plan (Factory)	Status on the date of Inspection	Pictorial Evidence
14	Based on the number and location of emergency lights observed,adequate illumination levels are not anticipated along egress routes on all floors.	Test the emergency lighting system on each floor and provide additional emergency fixtures to provide adequate illumination along the means of egress. Provide a minimum illumination of 10 lux at the floor level within exit stairs and exit discharge paths and minimum 2.5 lux along exit access aisles.	Within 3 months	On 8-12-15: Corrected. On 29-5-16: Corrected. On 24-11-16: Corrected. On 27/04/2017: Corrected. On 03/08/2017: Corrected as per previous follow-up. On 28/12/2017: Corrected On 15-5-2018: Corrected. On 24/06/2019: Corrected.	25-Feb-2015	Already tested the emergency lighting system by own lux meter and provided a minimum illumination of 10 lux at the floor level by our Fire Safety Officer.	Corrected

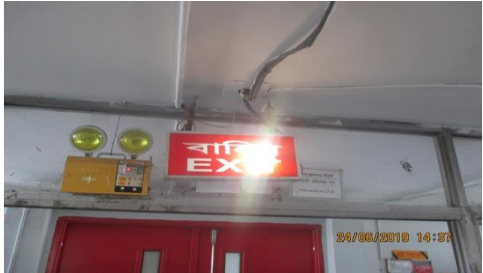
15	Manual on off switch is provided for emergency lighting of the spot type	Remove manual on/off switches from emergency lighting units to prevent them from being switched off.	Within 3 months	On 8-12-15: Partially corrected. On 29-5-16: Reportedly switches removed. But found non-functional while testing. On 24-11-16: Corrected. On 27/04/2017: Corrected. On 03/08/2017: Corrected as per previous follow-up. On 28/12/2017: Corrected On 15-5-2018: Corrected. On 24/06/2019: Corrected.	18-Dec-2015	Corrected.	Corrected

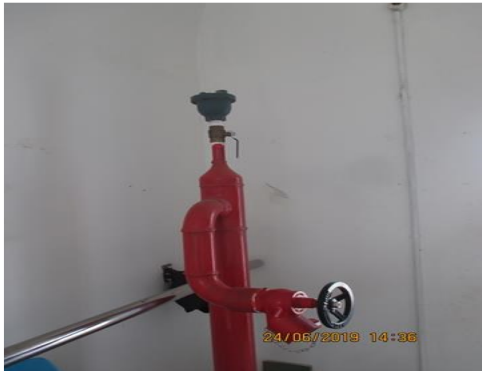
16	New Finding: The building has an occupiable floor greater than 10 meter (33 feet) and is not provided with standpipe system as per NFPA14.	Provide standpipe system as per NFPA14.	Design within 1 month, installation within 3 months	On 8-12-15: New Finding On 29-5-16: L/C has been opened on 21-4-16. On 24-11-16: Stand pipe design has been reviewed from ACCORD and installation is going on. On 27/04/2017: Installation is going on. On 03/08/2017: Reviewed design was available. Interfacing work is still pending. On 28/12/2017: Installation is complete factory will apply for witness testing. On 15-5-2018: Awaiting for T&Cx verification. Landing valves shall be listed/3rd party approved. Redundant ball valves shall be removed or provided with supervision at hose station as per NFPA 14. On 24/06/2019: T&C docx was submitted to accord. Awaiting for T&C VI.	08-Jun-2016	Installation completed	In Progress

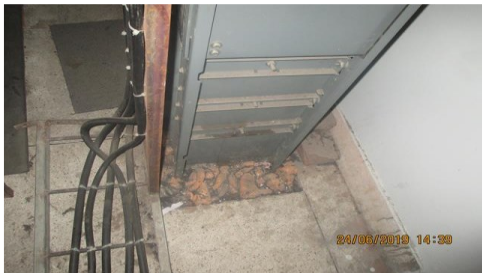
17	New Finding (5th follow up): Unsealed electrical shafts are located in the fire-rated floor	Provide a minimum 2-hr fire-rated shaft to separate the utility risers from each floor level and seal all penetrations in floor and ceiling assemblies to maintain the fire	Within 01 month	New Finding (5th follow up) On 03/08/2017: No action has been taken yet. On 28/12/2017: Corrected On 15-5-2018: Corrected. On 24/06/2019: Corrected as per previous follow up.	25-May-2017	Electrical Riser sealed with fire resistance foam	Corrected
